## Akin House: Powerpoint for Grant Proposal to Benefit Akin House Cultural Heritage Center

## Massachusetts Cultural Facilities Grant Proposal

# The Elihu Akin House. South Dartmouth, Massachusetts

# WHALE's First Inspection

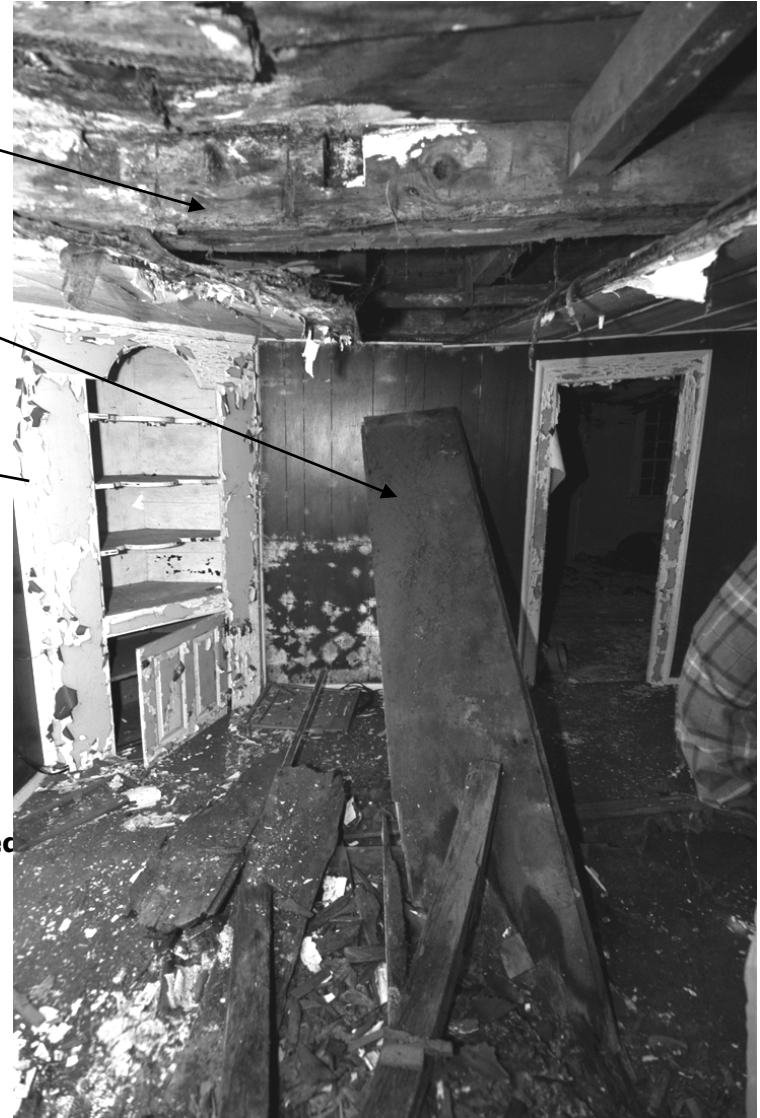
## Rooms E. and F. "Guest room and buttery"

Extensive water damage had caused the partition wall, joists, girt, end girt, ceiling, between rooms E. and F. to collapse.

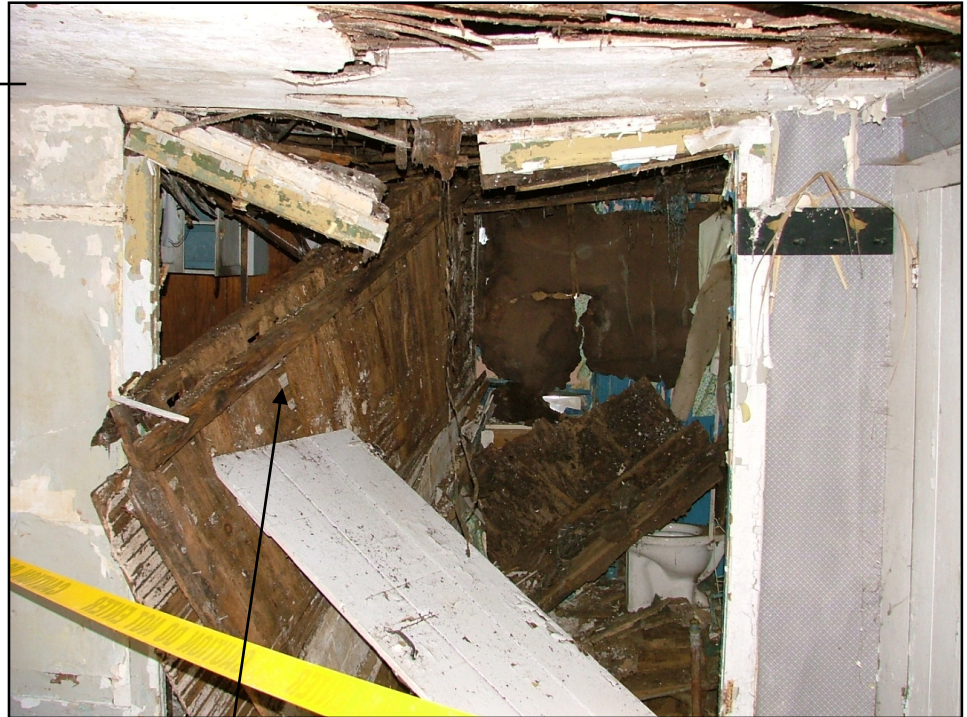
Room F. was original a buttery. In the 20th century it became a bathroom.

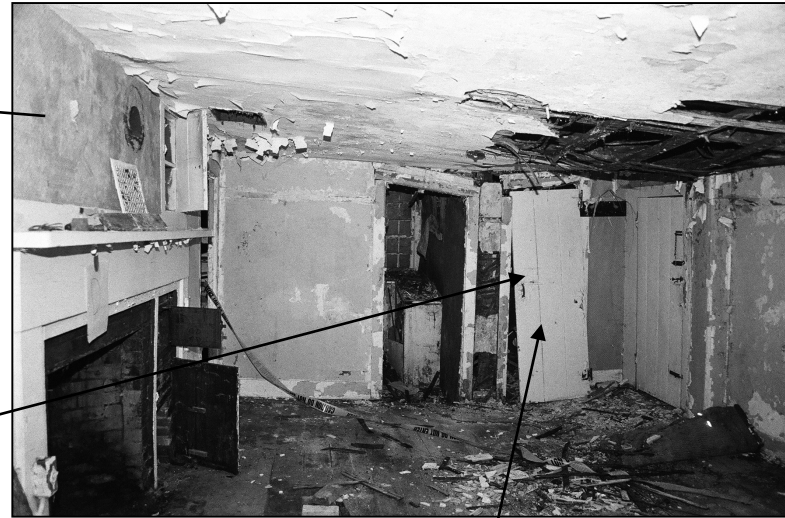
## Room D. Kitchen

The northeast corner of Room D and the entrance to Room F were in alarming condition.

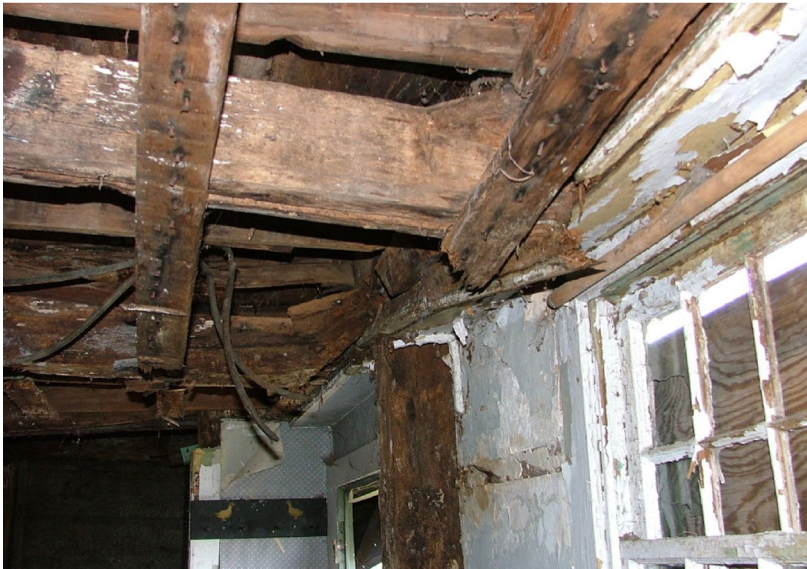
The water-damaged ceiling was also falling in.

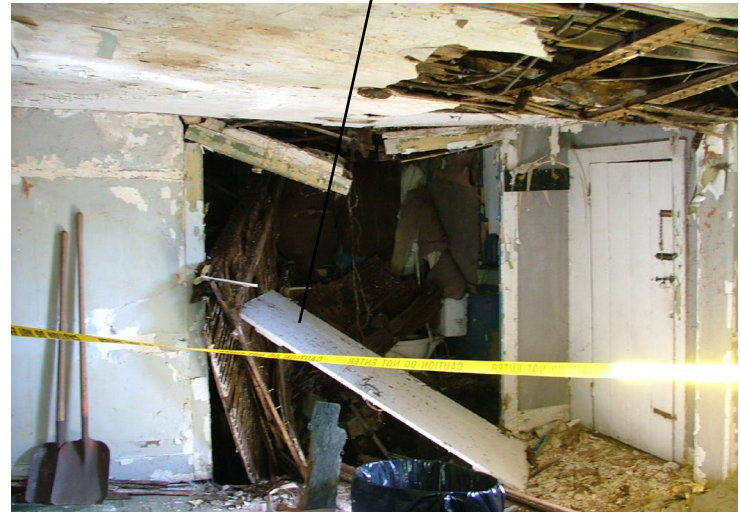
By April 2004, the northeast corner wall had collapsed.

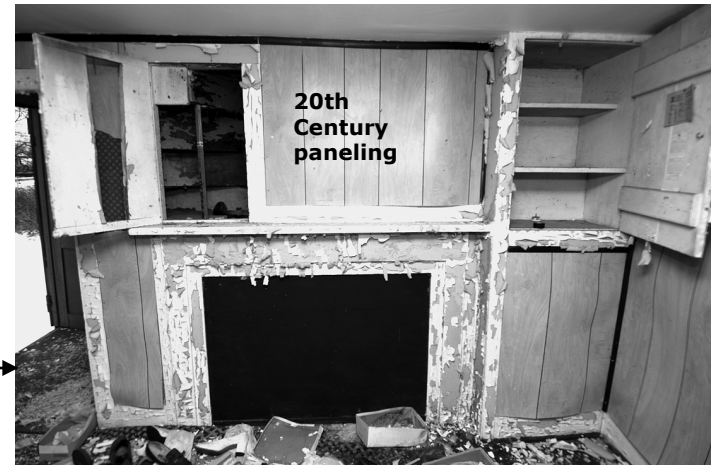
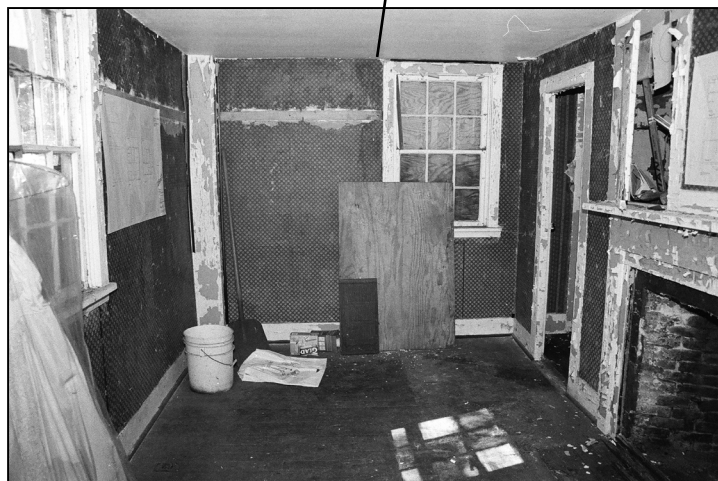
Walls are plastered with 4 layers of wallpaper.

The firebox has a Greek Revival surround.

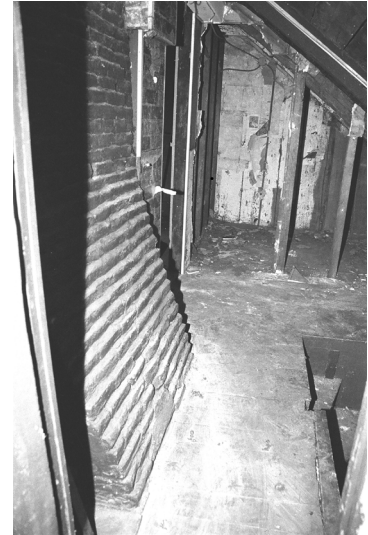
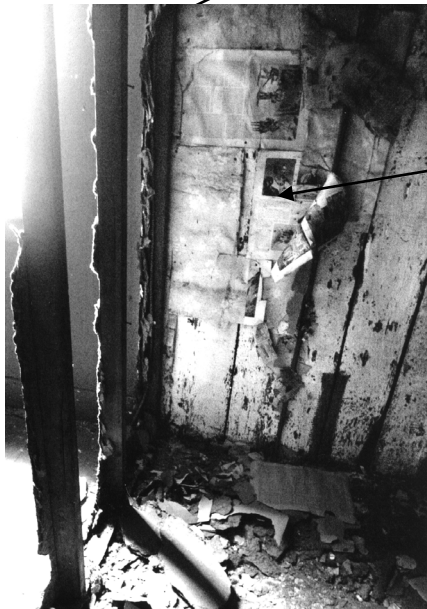
**South wall.** Interior side of vertical plank sheathing—white washed with 19th century graffiti.

**Room K.** In the late 19th century the white-washed boards were plastered.

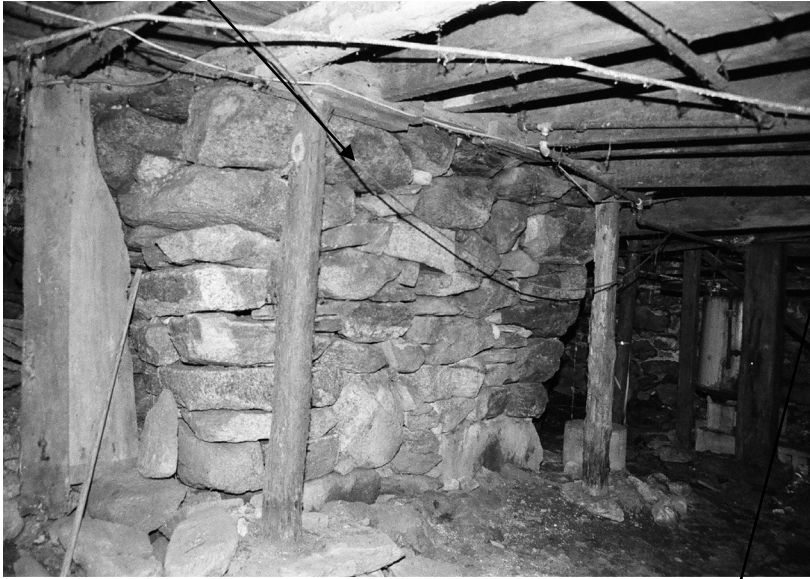
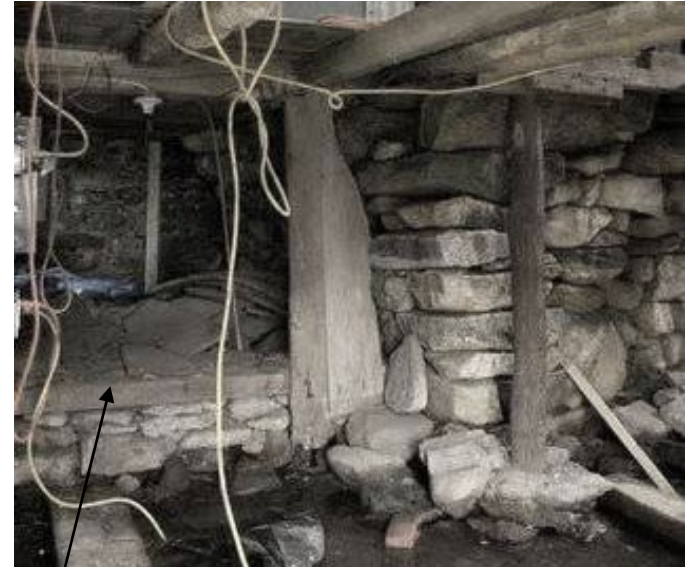
## The Cellar

The granite stones of the massive chimney foundation are cobbled outwards in order to carry the hearths for the fireplaces above. The foundation walls are granite field stones.

Southeast view of chimney foundation and root cellar

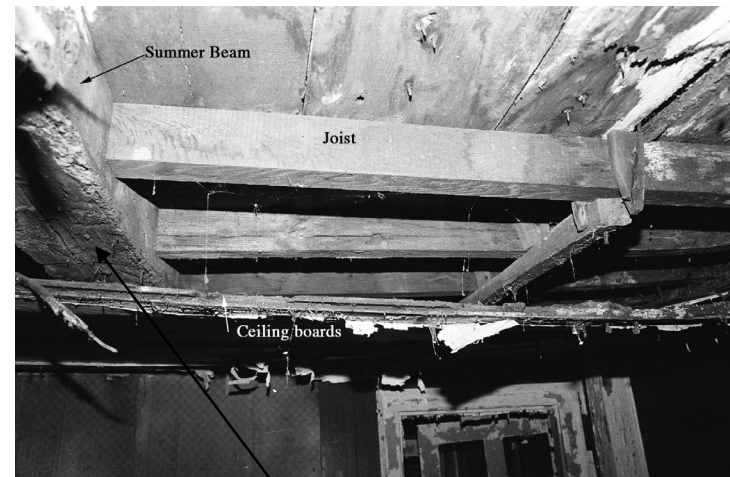
**The use of a summer beam goes back to the 17th century and earlier, but in this rural community this type of construction was still being used in 1762, although now hidden under a ceiling of wide ship-lapped pine boards suspended below the summer beam by hand made wooden holders.**

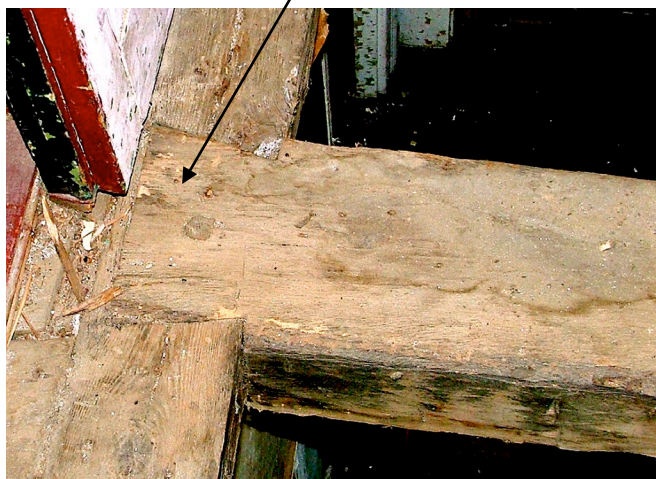
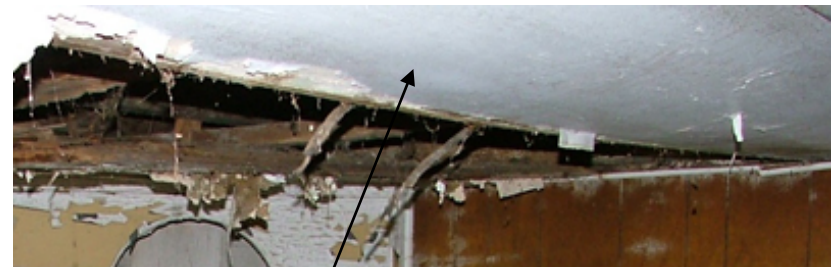
**Dovetail joinery**

**Originally whitewashed these 18 to 20 inch wide ceiling boards are rare and original to the structure.**

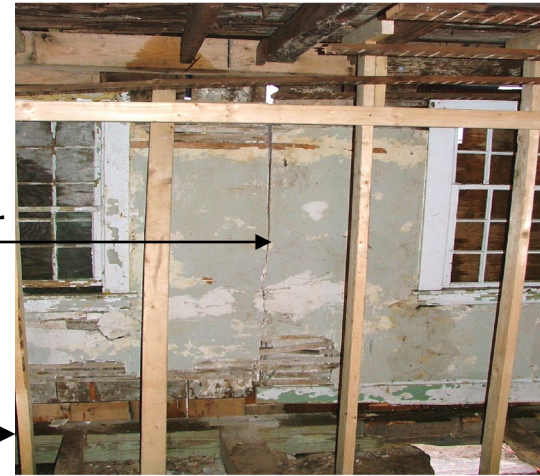
**Room D. Kitchen  
-East Wall-**  
In order to repair the sill and the plate the east wall was cut, removed, and stored and then reinstalled.

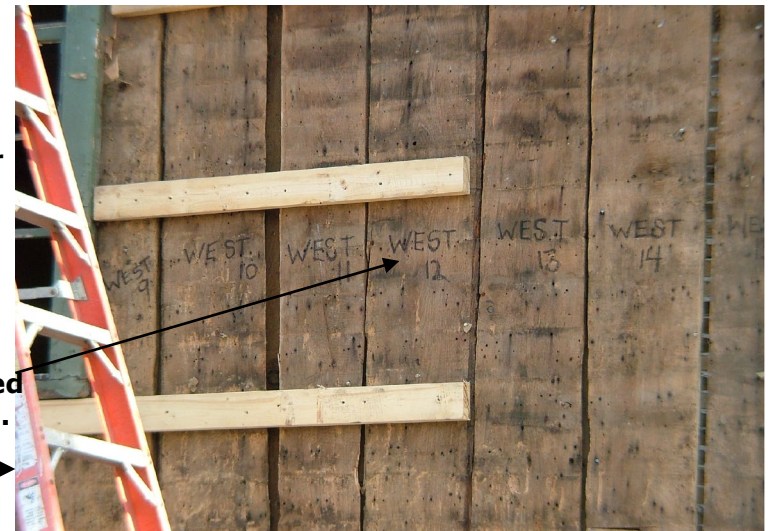
**Room A. Parlor  
-West Wall-**  
In order to repair the sill and plate, the sheathing was numbered, removed, stored and reinstalled.

Conservation work by the "Architectural Preservation Group." Warwick, RI

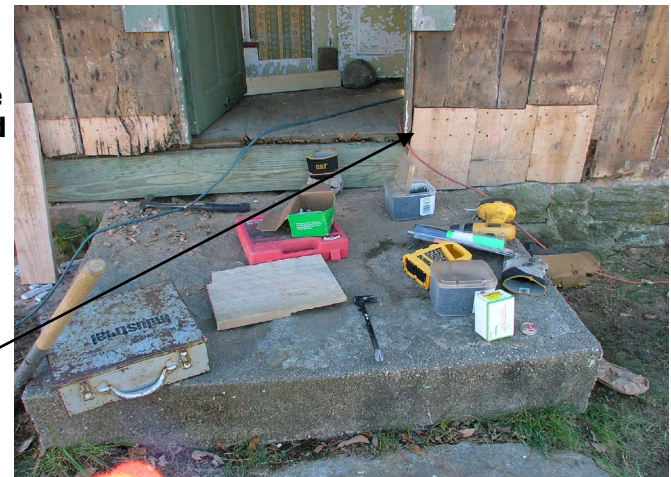
The broken and decaying section of the summer beam was replaced with a new piece identical to

The joists on the east side of the summer could be saved. The rotted joists and plate on the west side were replaced with identical material

The damaged bottoms of the vertical sheathing were repaired in place

Conservation work by the "Architectural Preservation Group." Warwick, RI

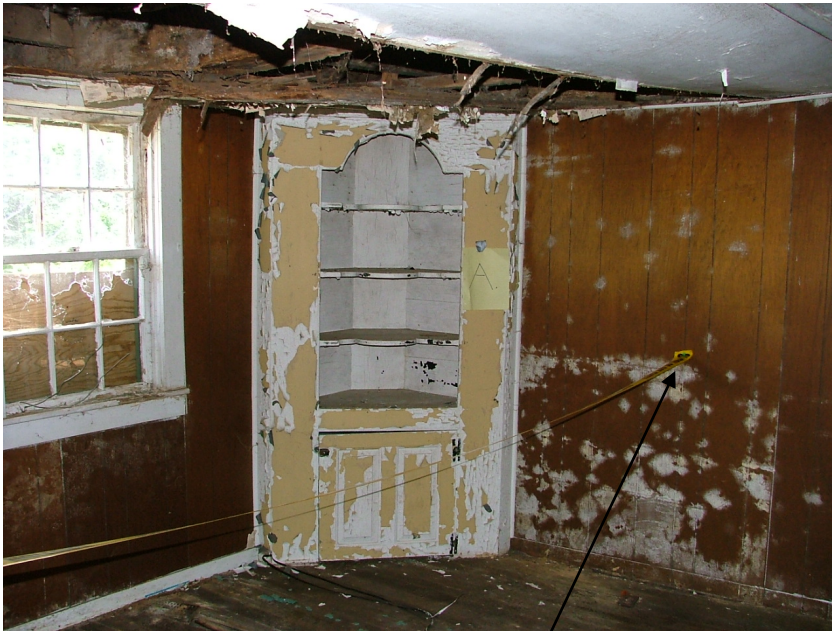
Room A

Behind the mid-20th century wall paneling were many layers of wallpaper attached to the original hand-planed and whitewashed interior boards. It was probably between these efforts to modernize that late 1800s Federal trim, Federal doors, beaded post casing and the corner cupboard were installed.

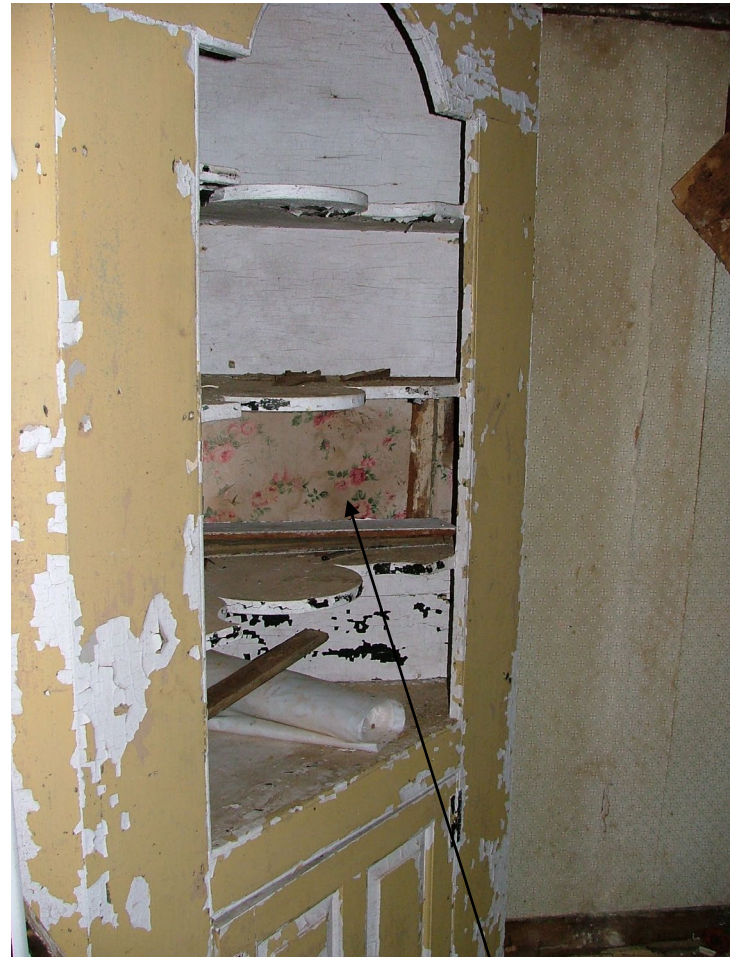
Earlier layers of wallpaper discovered behind the cupboard.

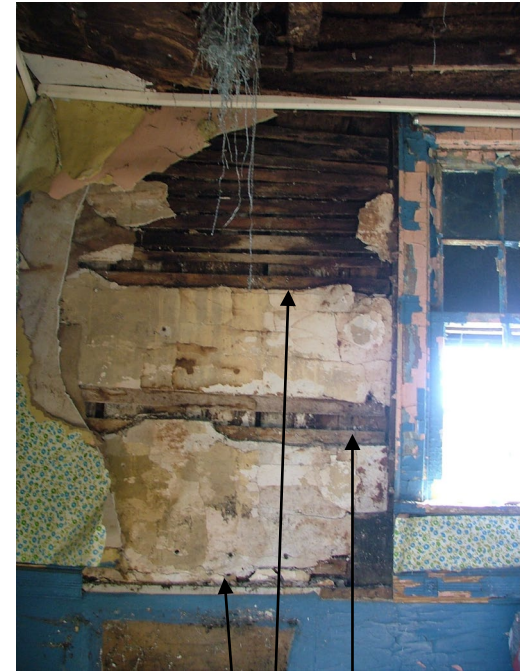
**Room F**

**Marks of the buttery shelves before the room was changed to a bathroom.**

**By 2003 the sink, toilet, and bathtub had fallen into the cellar.**

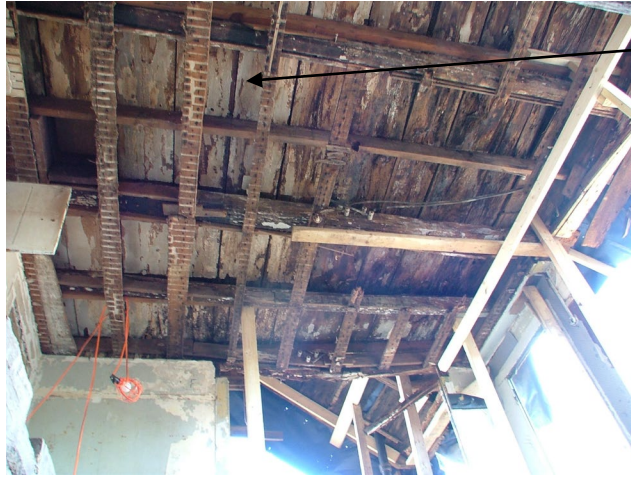
**Room A**

Whitewashed original ceiling boards and a section of the later 19th century plastered ceiling will be preserved.

Original joists and various replacements will be displayed under Plexiglass so that original construction details can be safely viewed.

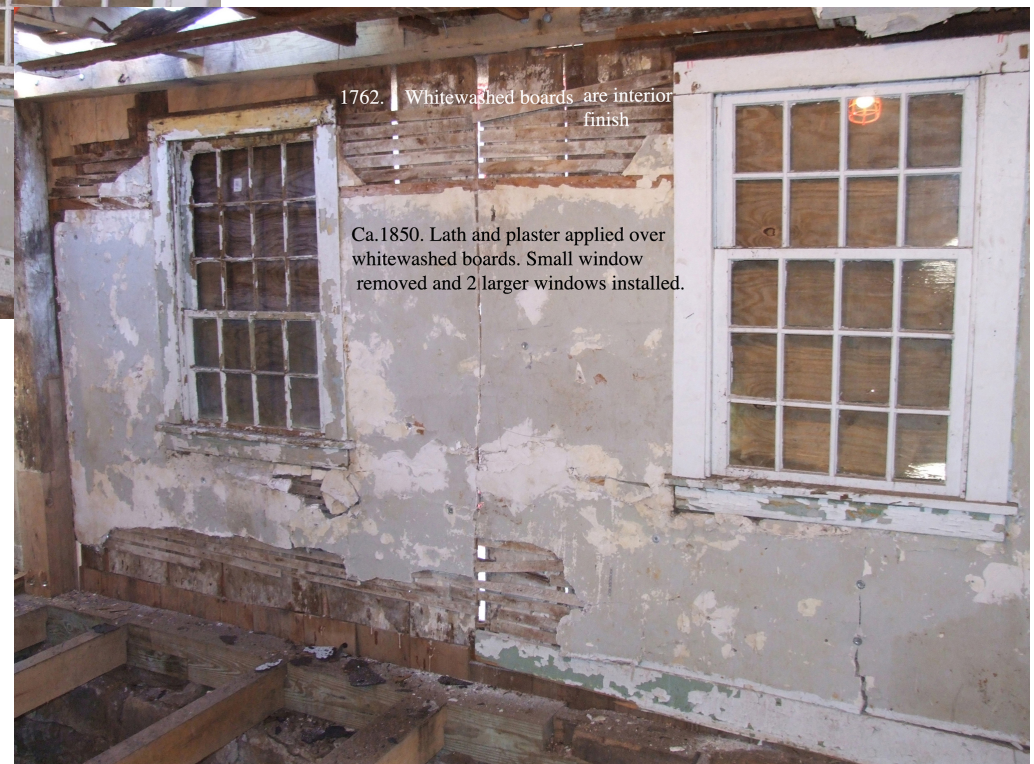
**Location of single original kitchen window.**

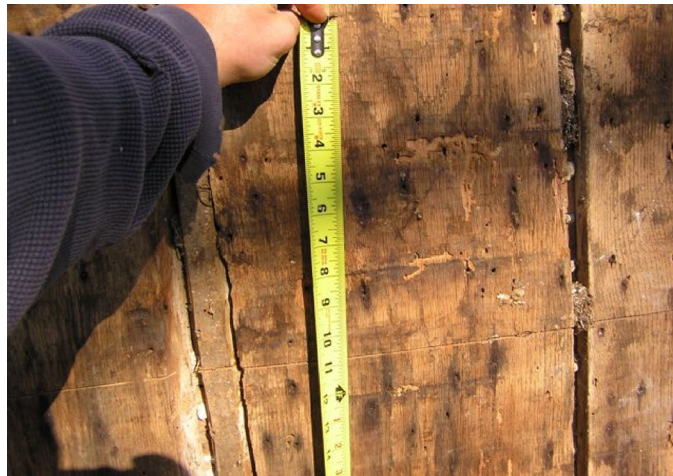
**Clapboards followed by shingles.**

**To be under the Plexiglas:  
Explanation and display of both clapboards and shingles and the forensic marks they leave behind.**

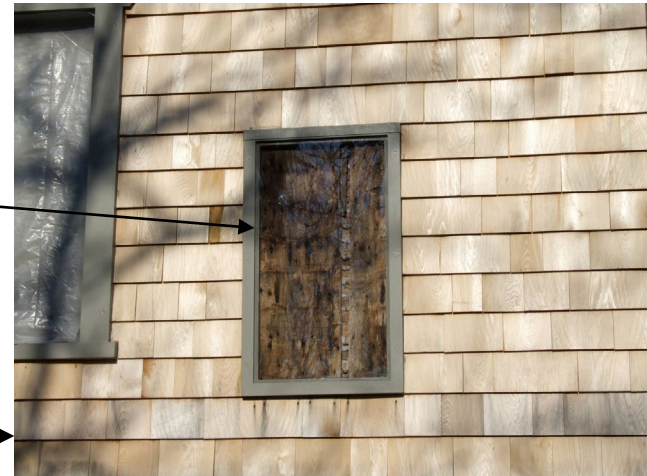
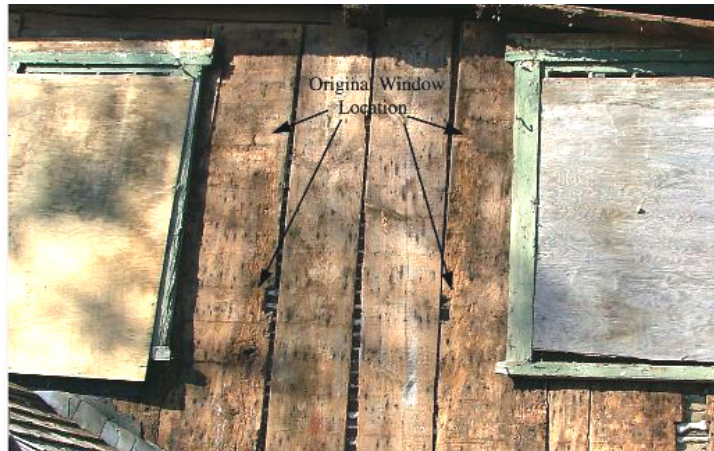
**The location of an original window.**

**To be under the Plexiglas  
The display will show and explain how to recognize notches and shadow lines of an original window.**

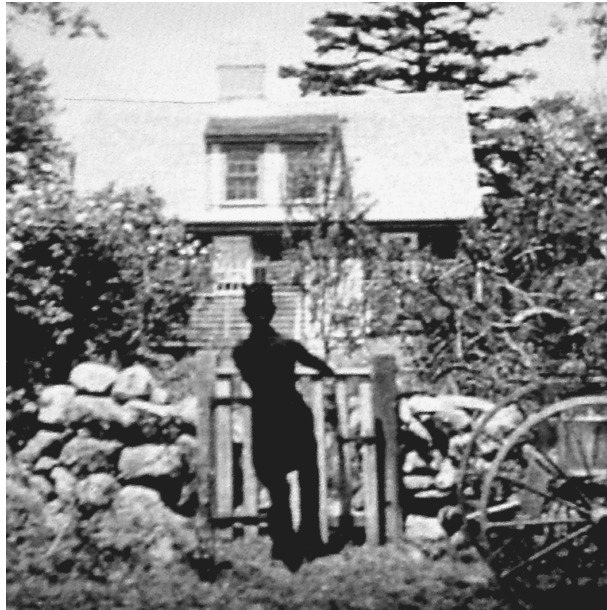
**East View**

In this 1922 movie still, the 19th century dormer was still intact. Unfortunately when it was added a rafter was cut which caused it to gradually cave inward and contribute to the water damage.
